# ***Field Operations Program Chevrolet S-10 (Lead-Acid) Accelerated Reliability Testing – Final Report***

Published July 1999

**Idaho National Engineering and Environmental Laboratory  
Automotive Systems and Technology Department  
Idaho Falls, Idaho 83415**

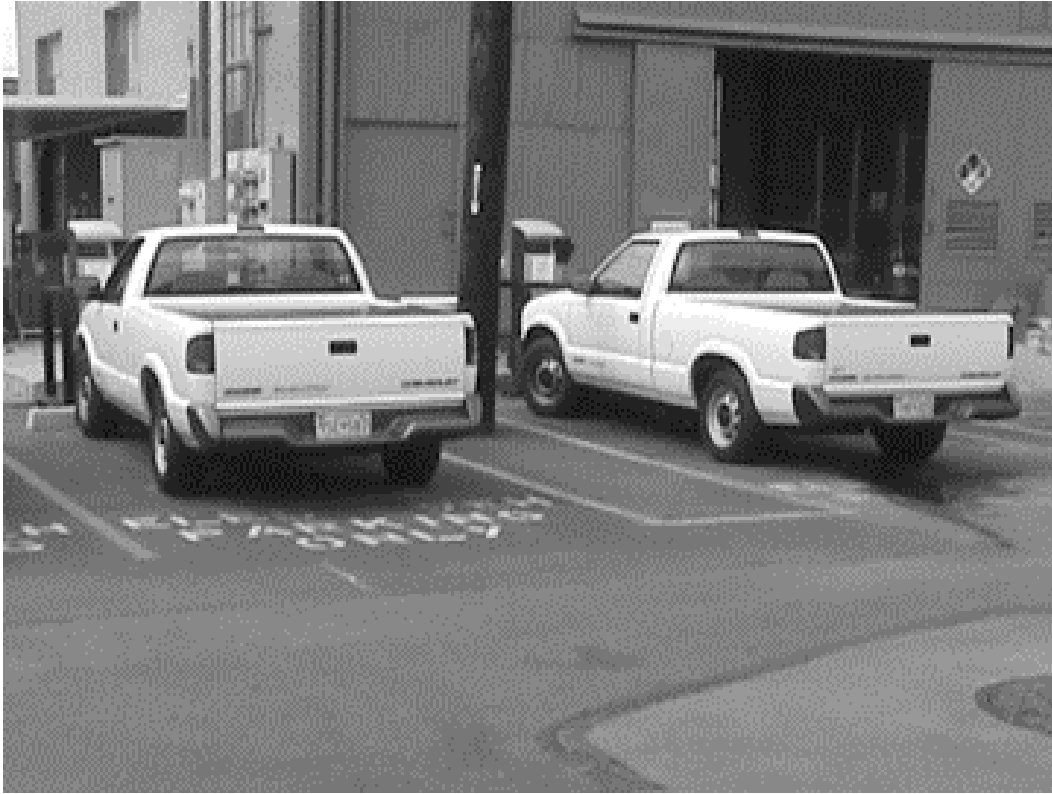
**Figure 1.** Chevrolet S-10 accelerated reliability test Vehicles 497 and 499 being charged at the Electric Transportation Applications facility.

The vehicles, as shown in Figure 1, were equipped with 26, 12-volt, 48-Ah (C/2) Delphi modules in a single string. The vehicles were charged exclusively using Delco inductive chargers with an output of 6.6 kW (OEM charger). The vehicles were operated daily to average 500 miles per week. Vehicles 497 and 499 were placed in service in September 1997, and respectively accumulated 25,060 miles and 25,077 miles of service through November 17, 1998 (the date of the final range test). Figures 2 and 3 present monthly mileage accumulated on each vehicle.

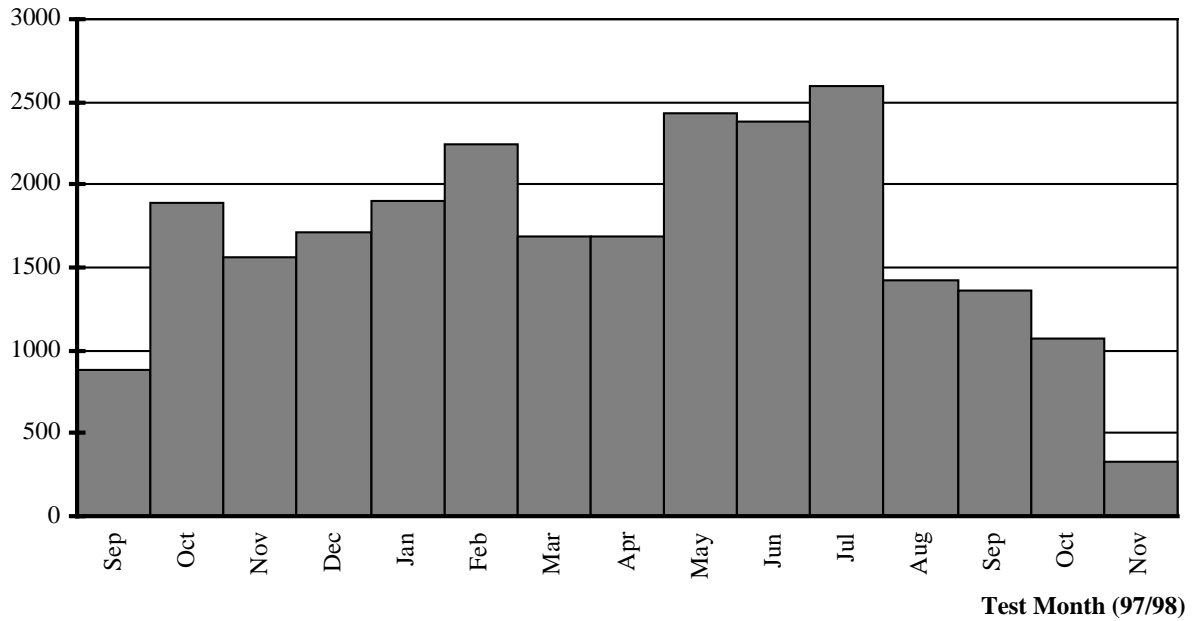
**Figure 2.** Miles driven per month by ETA Vehicle 497.

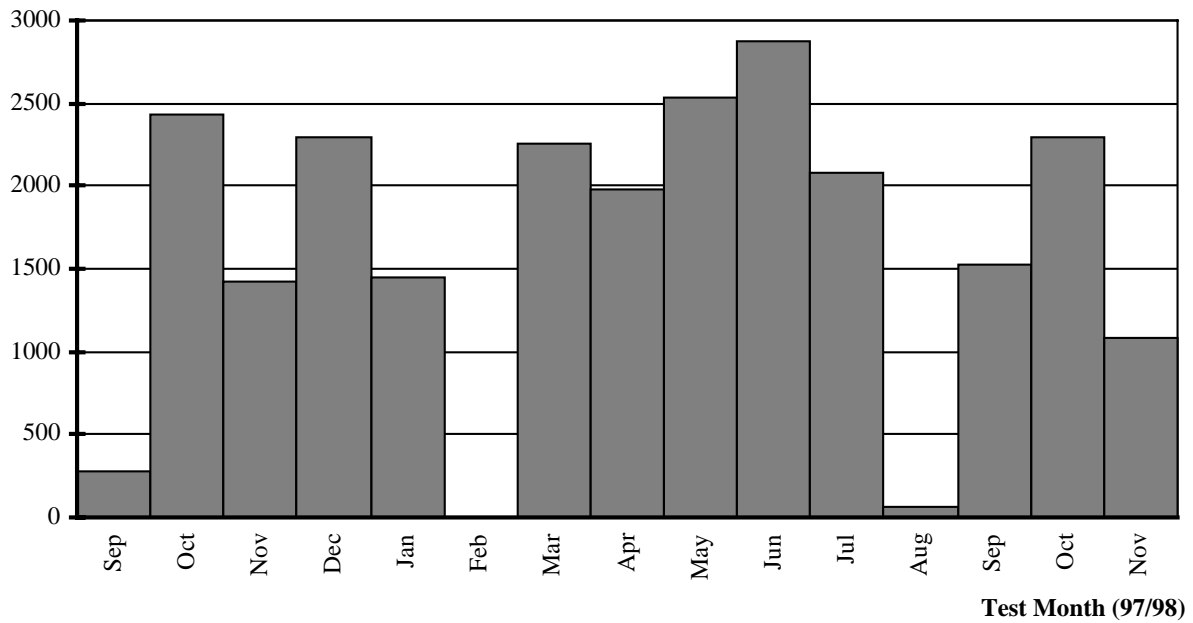
**Figure 3.** Miles driven per month by ETA Vehicle 499. During February 1998, Vehicle 499 was out of service due to a collision. During August and September 1998, Vehicle 499 underwent warranty work and a module replacement.

Total mileage on Vehicle 499 was reduced by its involvement in a traffic accident. The vehicle was hit from the rear by a pickup truck on Interstate 17 and forced into the rear of a large delivery van. Vehicle 499 suffered damage to both the front and rear of the vehicle; no damage was sustained by the drive system, batteries, or charge port. Repair of the vehicle was performed promptly by the local Chevrolet dealer once approval from the insurance company was received. No long-term affects of the damage or repair have been apparent in the subsequent operation of Vehicle 499.

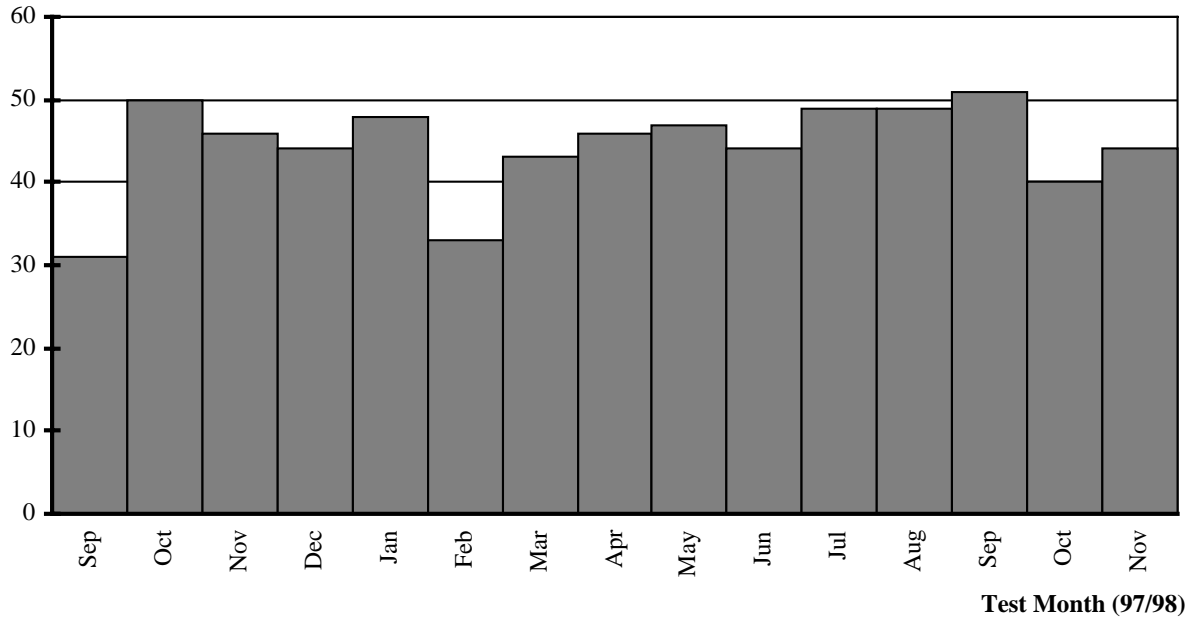
**Figure 4.** Usable vehicle driving range (miles) by month for ETA Vehicle 497.

- Charge times also varied significantly due to environmental factors. The S-10 Electric battery pack is actively cooled by the vehicle's air conditioning system. Refrigerant is diverted to a battery pack evaporator/fan when battery pack temperatures exceed 45° C. The high ambient temperatures in Phoenix presented a significant challenge to the pack cooling system. During summer daylight hours, air conditioning resources were always diverted to pack cooling, leaving the cabin without air conditioning. It was only well after dark that the pack would ever cool enough for pack cooling to stop and divert refrigerant back to the cabin. This was the source of many negative driver comments with regard to cabin comfort. The high battery pack temperatures also frequently extended charge times as the chargers significantly reduced charging power at high battery temperatures. On a positive note, the high battery temperatures contributed to increased range (for the S-10) during warm Phoenix days as can be seen from Figures 4 and 5.

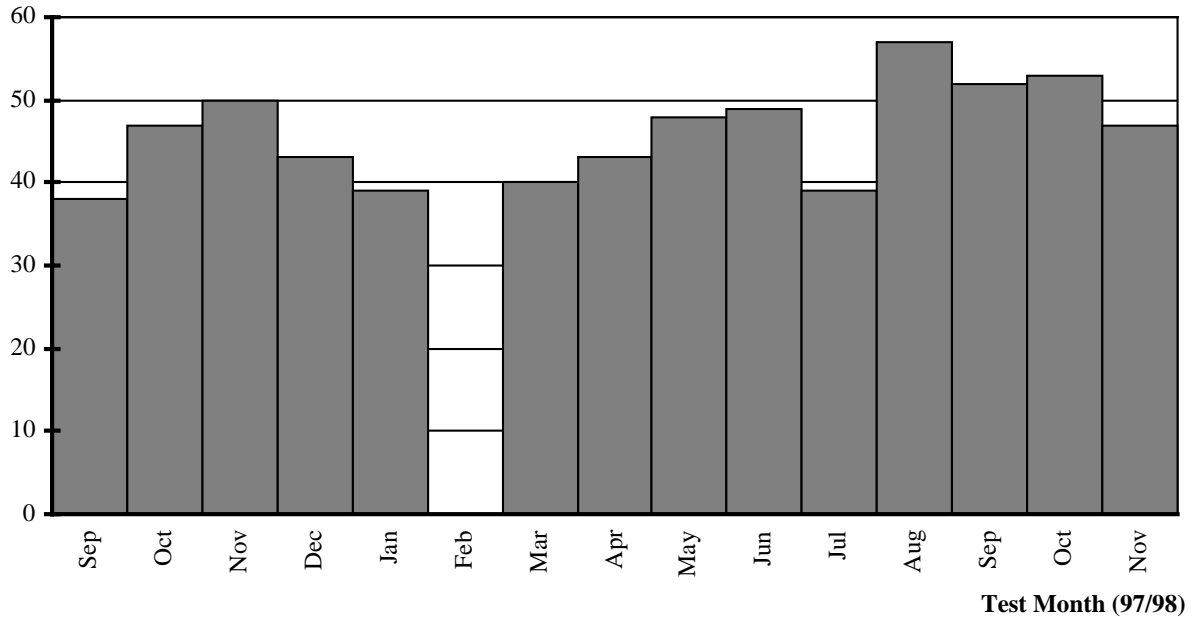
**Figure 5.** Useable vehicle driving range (miles) by month for ETA Vehicle 499. Vehicle 499 was not driven during February due to a collision.

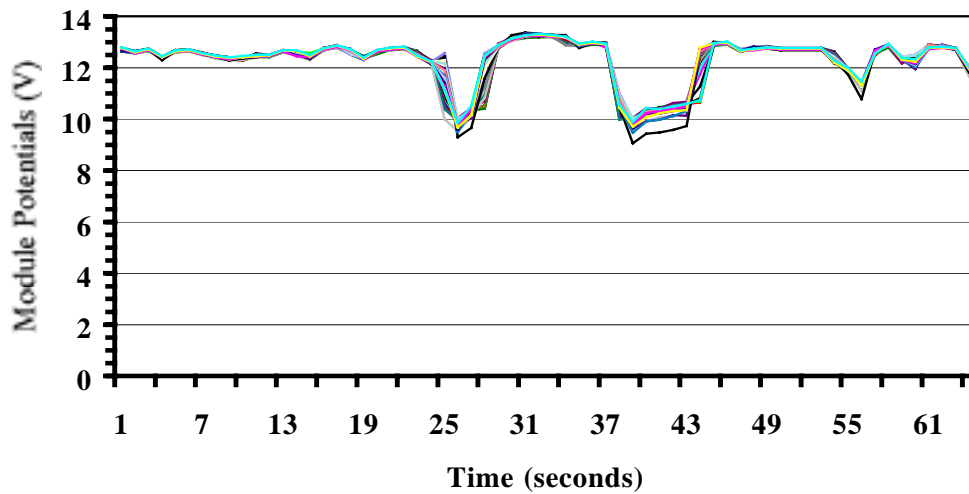
**Figure 6.** Test results for ETA Vehicle 497 battery module voltages under load.

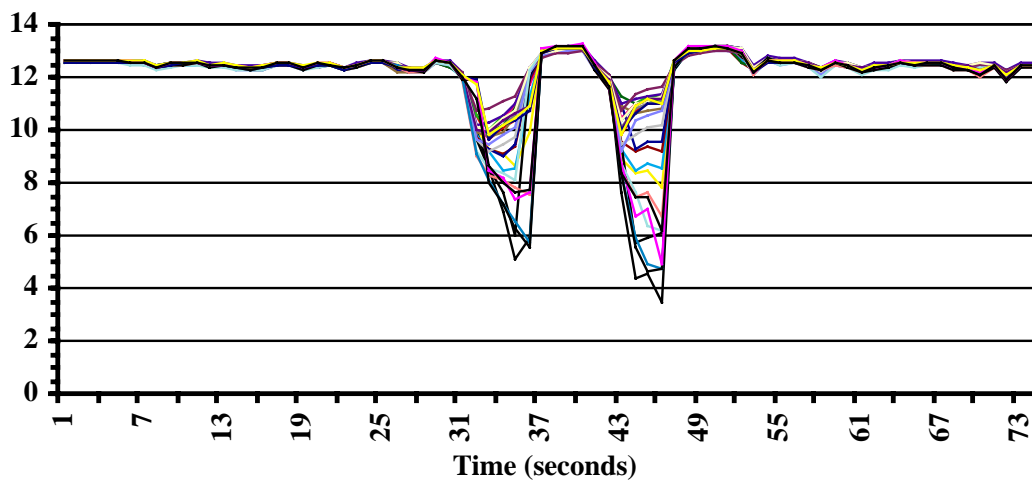
**Figure 7.** Test results for ETA Vehicle 499 battery module voltages under load.

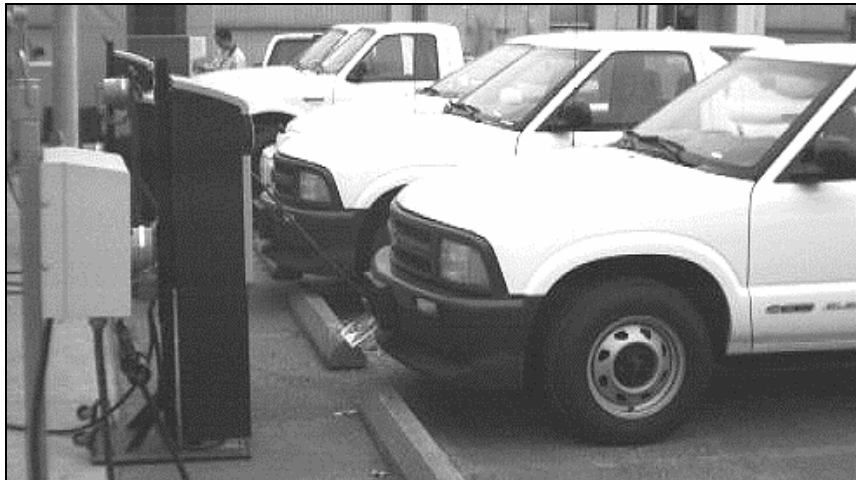
**Figure 8.** S-10 vehicles being charged at Southern California Edison's Electric Vehicle Technical Center.

Before the vehicle testing commenced, employees with a commuting distance sufficiently long (but within the maximum range of the vehicle) were selected to be users of the vehicles. Soon after the vehicles were put in service, it became apparent that because of the limitations of the vehicles in terms of range and functional reliability, the three S-10s would have to be assigned to different users with shorter range requirements (15 to 20 miles round-trip commuting distance). Throughout the rest of the test period, most of the S-10s were shifted between different users or assigned to the EVTC (Figure 8) to be cycled and used for daily operations.

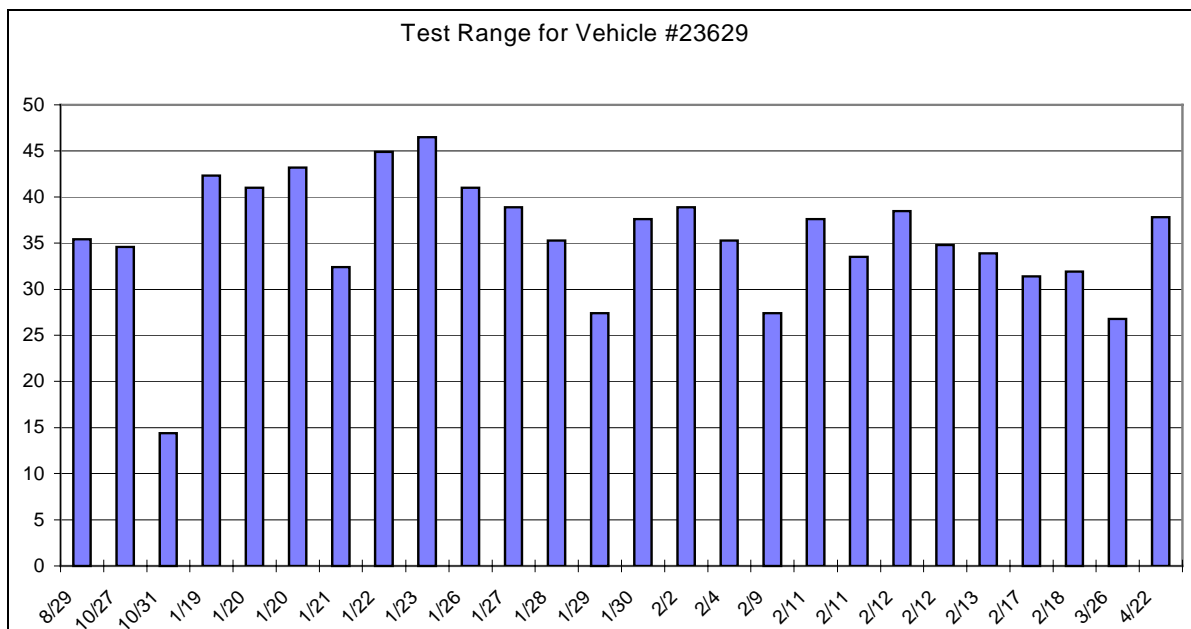
**Figure 9.** SCE vehicle 23629 Urban Pomona Loop Test Range. The left axis is miles (0 to 50).

shown in Figures 9, 10 and 11. The vehicle reassignments did not result in any range improvements, but it did reveal the fact that the range was highly dependent on ambient temperature, with a difference of as much as 10 miles between morning and afternoon drives. The vehicles were assigned to users with one-way commuting distances of 6 to 19 miles. When repairs were needed, they were made at the EVTC, and then a range test was conducted.

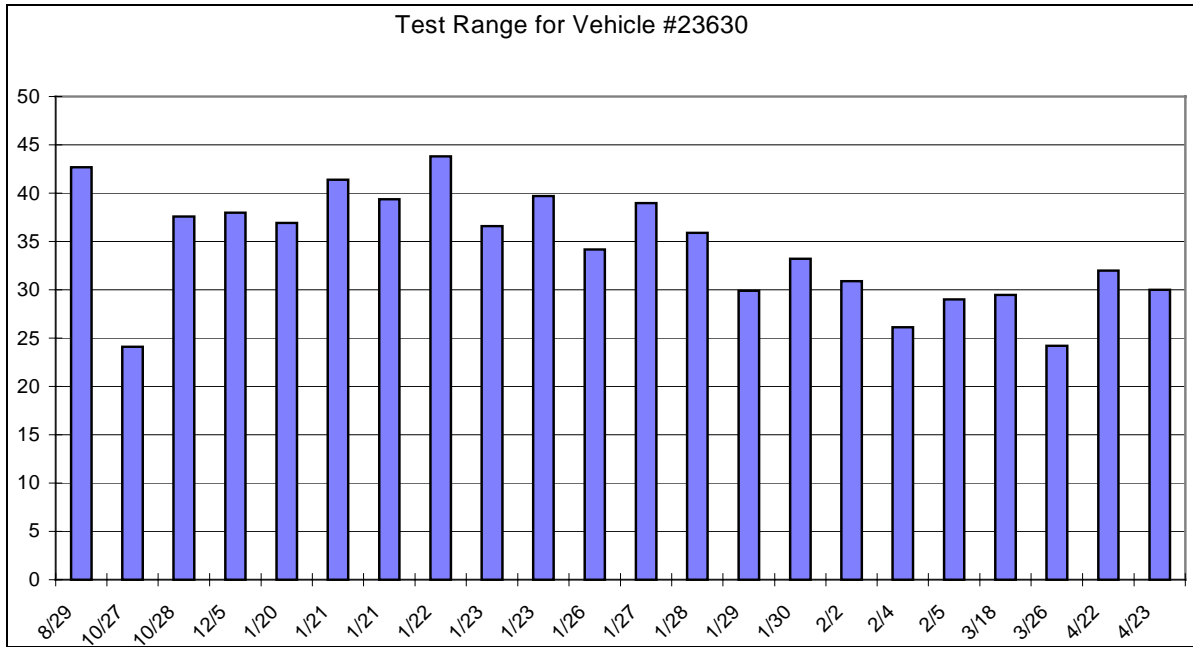
**Figure 10.** SCE Vehicle 23630 Urban Pomona Loop Test Range. The left axis is miles (0 to 50).

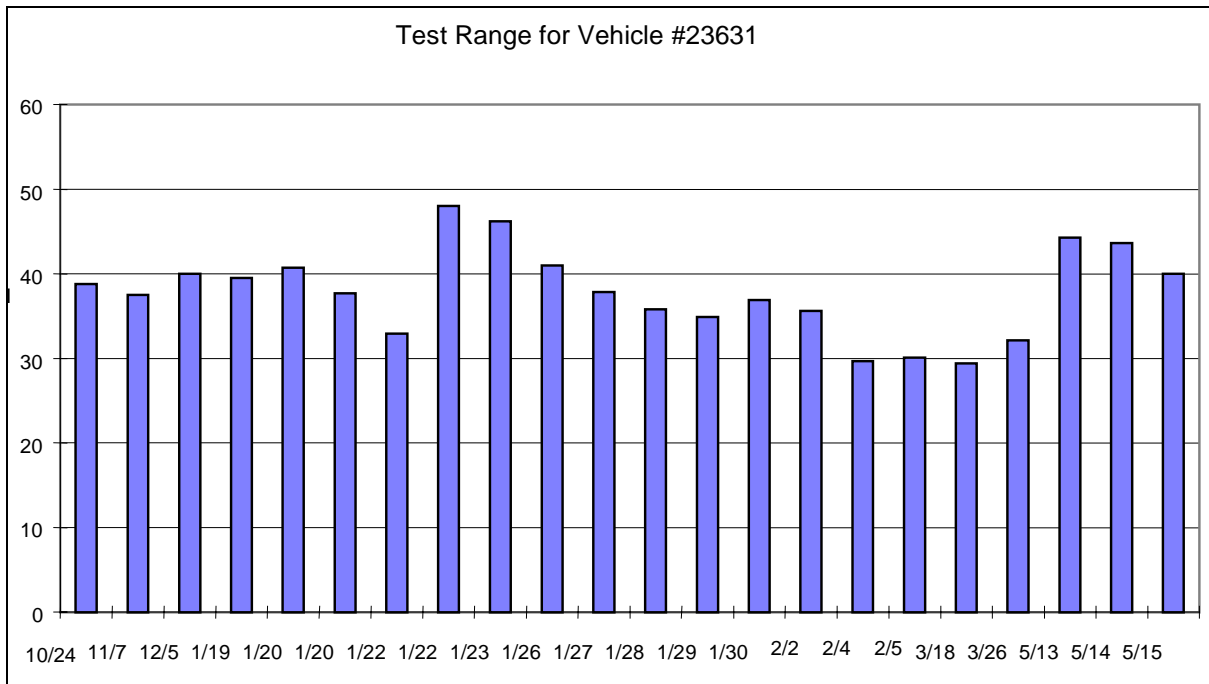
**Figure 11.** SCE vehicle 23631 Urban Pomona Loop Test Range. The left axis is miles (0 to 60).

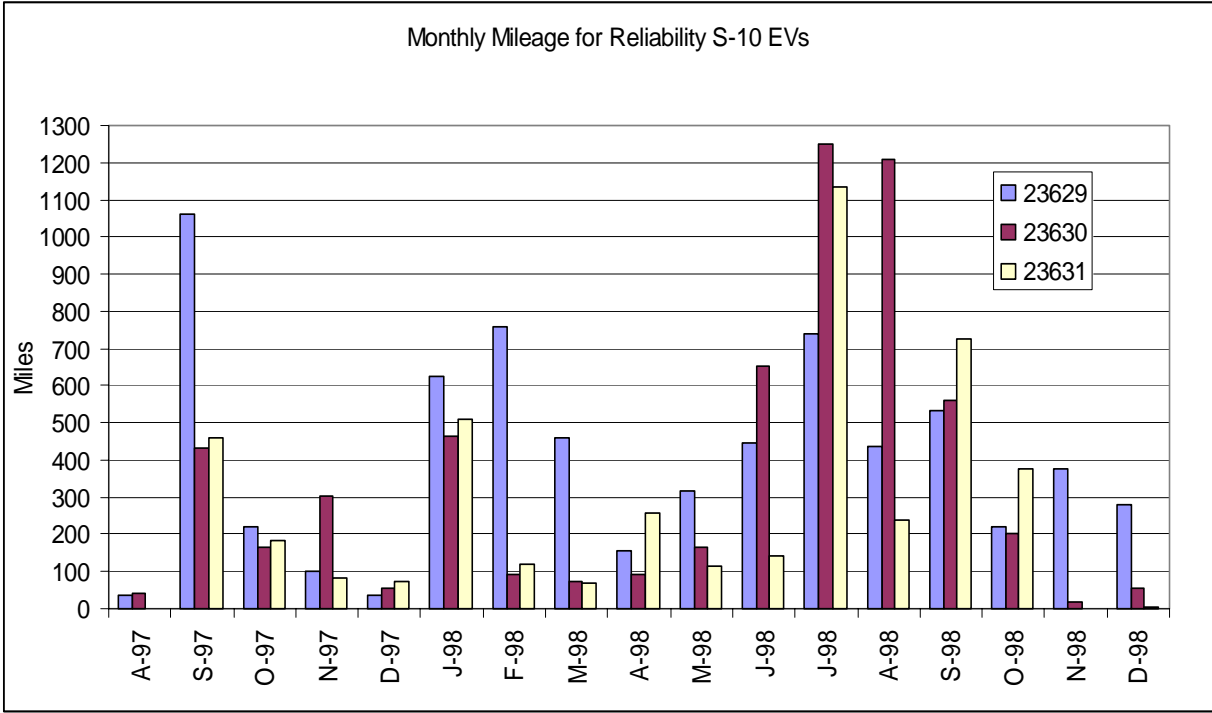
**Figure 12.** Monthly mileage for SCE’s S-10 electric vehicle reliability vehicles.

Figure 12 shows the monthly mileage for the three vehicles, and documents that SCE was not able to get consistent mileage from the vehicles due to breakdowns and required repairs. Figure 13 shows the progression of odometer readings of the vehicles. The periodic decreases in slope of the graphs are, again, representative of vehicle breakdowns and the resulting time-out-of-service for repairs.

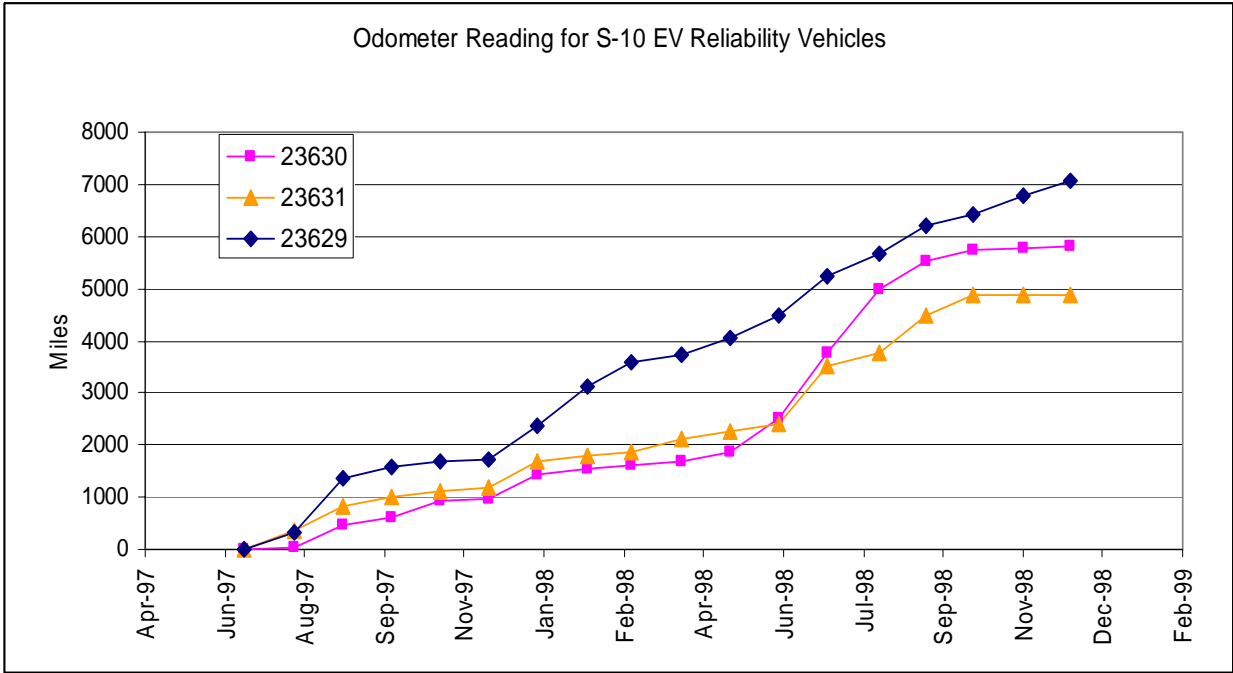
**Figure 13.** Odometer reading for Reliability Vehicles.

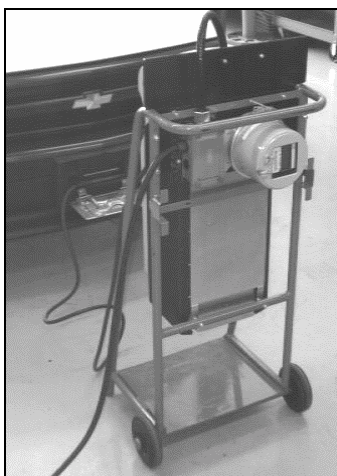
**Figure 14.** S-10 charger mounted on cart with ABB kWh meter.

The ABB meter (Figure 14) data for 1998 is shown in Table 3. For the fourth quarter, energy data was not collected for vehicle 23629 – the only one kept in service. The other two vehicles were kept at the EVTC after being returned due to low range. They were tested on the road and in the shop, where the battery pack was discharged with a load bank and then recharged. Therefore, the data in Table 3 for 23630 and 23631 shows energy usage with little or no mileage on the vehicles for those months.

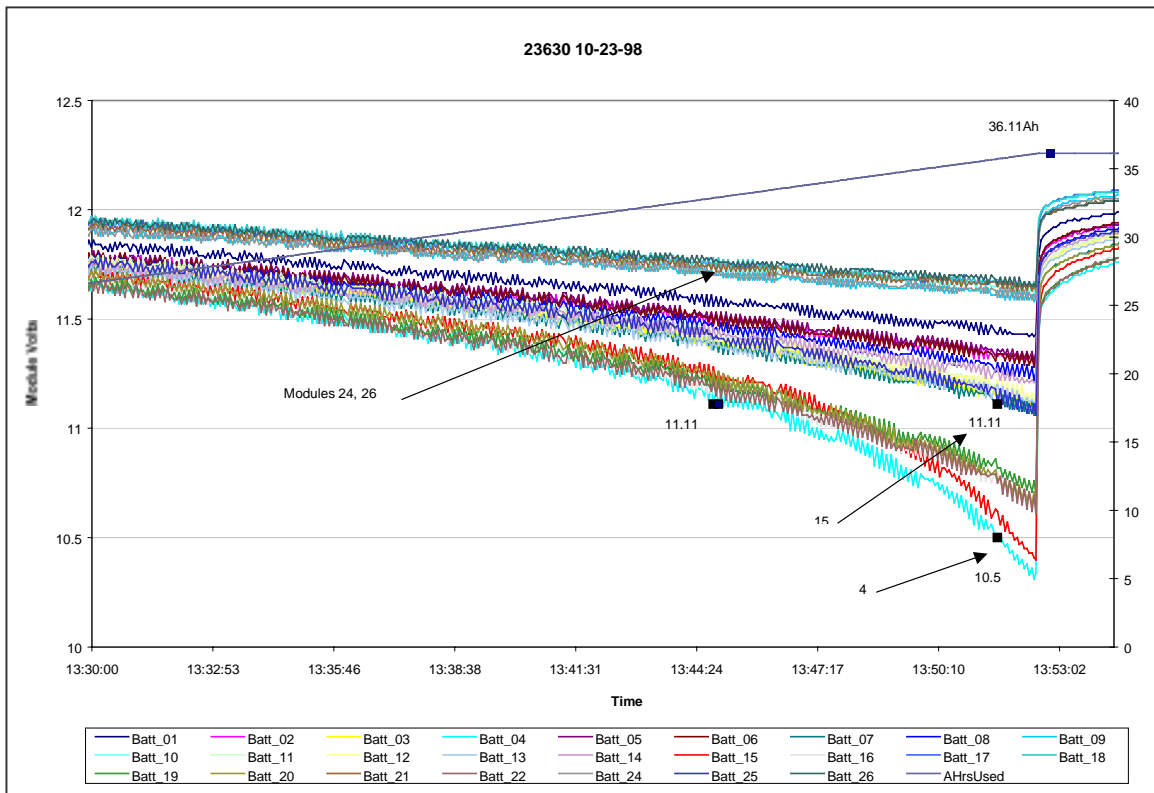
**Figure 15.** Discharge capacity test for Southern California Edison vehicle 23630 on October 23, 1998.

Vehicles 23629 and 23631 had battery modules replaced. Graphical representations of the discharge capacity tests for vehicles 23630 and 23631 are below (Figures 15 and 16). Note that the nominal capacity for the Delphi 19010704 VRLA battery is 48 Ah at the C/2 rate.

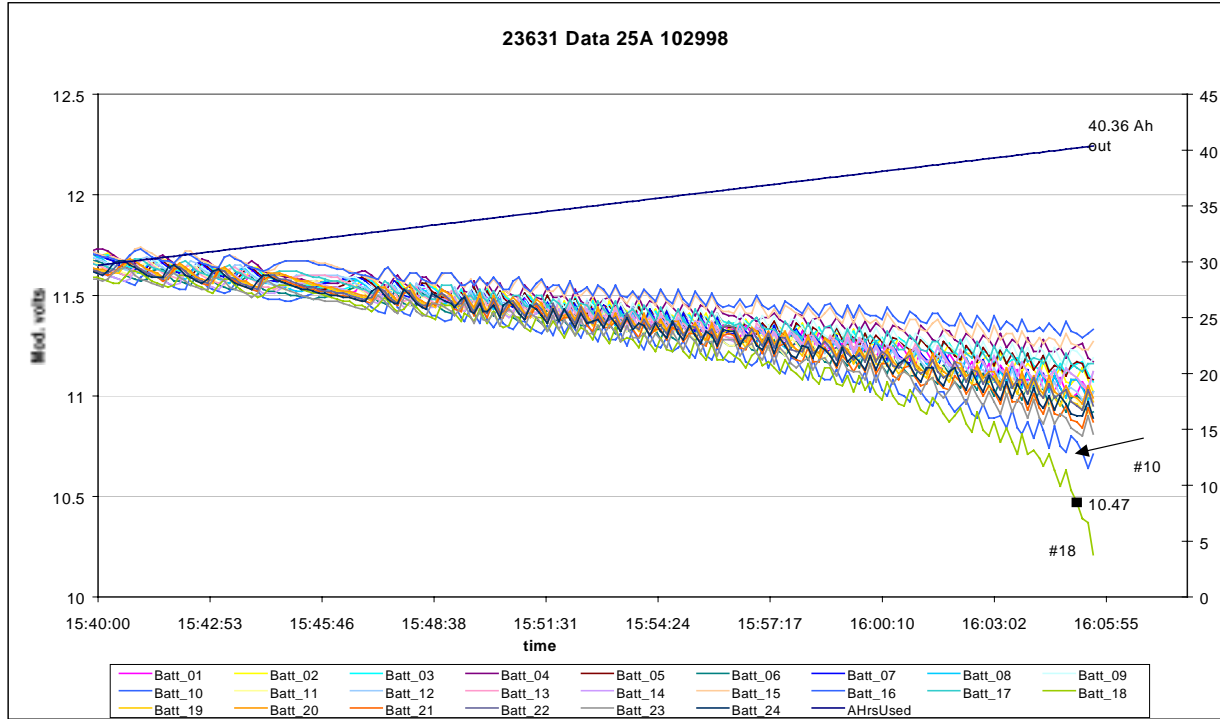
**Figure 16.** Discharge capacity test for Southern California Edison vehicle 23631 on October 23, 1998.

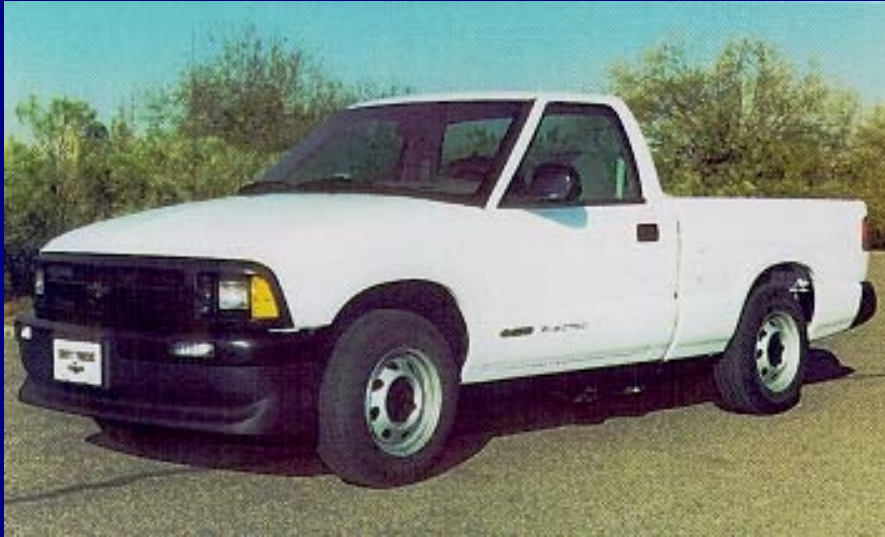
**1997 CHEVROLET S10 TRUCK**

The following pages contain the S-10 Fact Sheets for the Baseline Performance (EVAmerica) testing performed by ETA and the Pomona Loop testing performed by SCE. These Fact Sheets and Fact Sheets for other electric vehicles tested by the Field Operations Program and its testing partners can be viewed at the Program's web site: <http://ev.inel.gov/sop>.

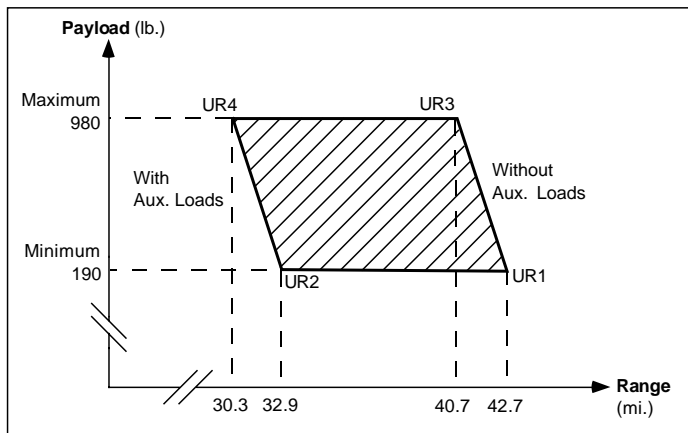
### Urban Range

TEST	UR1	UR2	UR3	UR4
PAYLOAD (LB.)	190	190	980	980
AC kWh RECHARGE	16.93	17.59	19.21	20.24
AC kWh/MI.	0.396	0.535	0.472	0.668
RANGE (MI.)	42.7	32.9	40.7	30.3
AVG. AMBIENT TEMP.	77° F	91° F	89° F	90° F

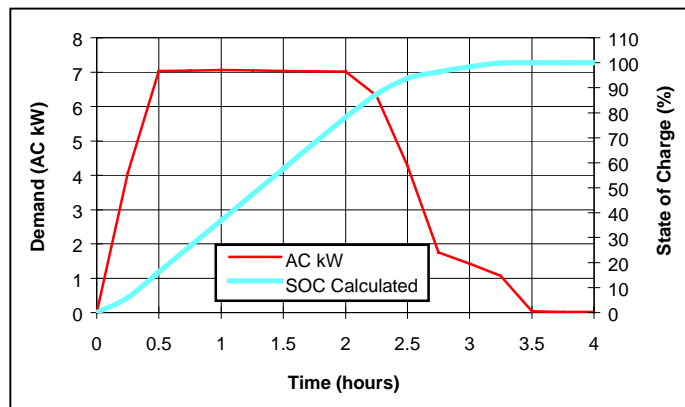
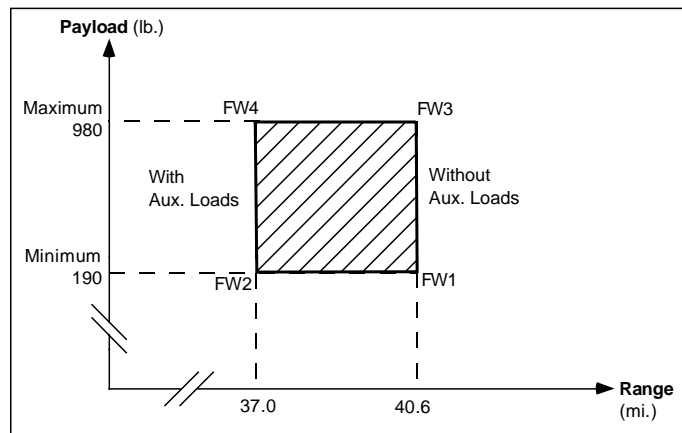
### Freeway Range

TEST	FW1	FW2	FW3	FW4
Payload (lb.)	190	190	980	980
AC kWh Recharge	19.29	15.80	16.38	16.02
AC kWh/mi.	0.475	0.427	0.403	0.433
RANGE (MI.)	40.6	37.0	40.6	37.0
AVG. AMBIENT TEMP.	92° F	87° F	83° F	82° F
